SAFETY IMPACT

of Traffic Control Intervention at Work Zones

The combination of work zones and passing traffic can be hazardous. Busy environments with moving vehicles and limited space make drivers, pedestrians, and especially workers, all vulnerable. This study tested the introduction of new, highly reflective materials to improve work zone layout visibility for drivers. What resulted were significant reductions in speeds and an improvement in overall speed limit compliance.

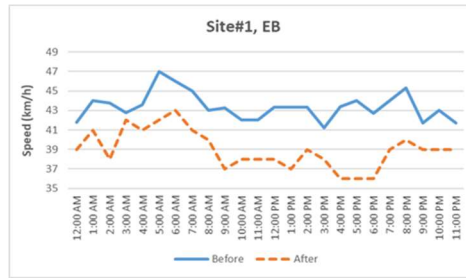
Before and After Average Speed Results from Test Site #1, Eastbound

The before and after test results indicated that speeds at the work zones did significantly reduce after the interventions, dropping an average of between 4.7 km/h to 11.6 km/h in the respective test sites, while no observable drop
