UNIVERSITY OF  
ALBERTA

# Asbestos Management Program

Facilities and Operations

Revision #5: May 12, 2016

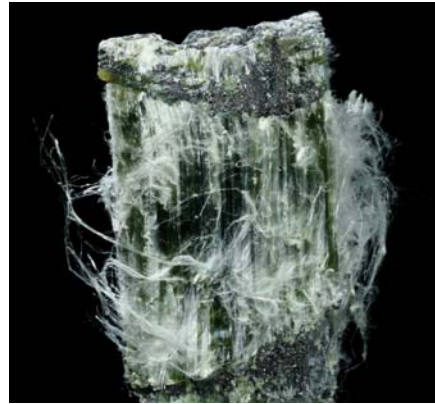
Asbestos is a naturally occurring, strong mineral fibre that is resistant to heat and many chemicals. It differs from other minerals because of its fibrous, crystalline structure that can be separated into flexible fibres.

Chrysotile asbestos (mineral form)

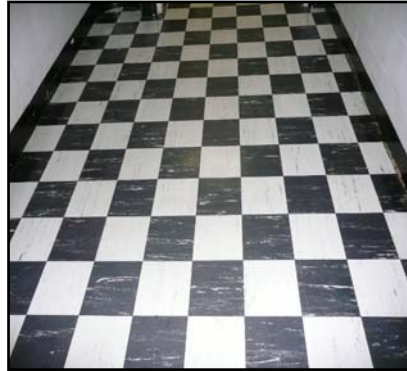
12"x12" and 9"x9" tiles have been generally found to contain 1% to 10% Chrysotile asbestos. The asbestos fibres in VATs are tightly bound into the matrix of the tile and are considered non-friable.

**Precautions:** Do not cut or break dry tiles. Only trained University staff may remove less than 10 square feet with hand tools using low risk procedures specific to this activity.

Vinyl asbestos tile (VAT)

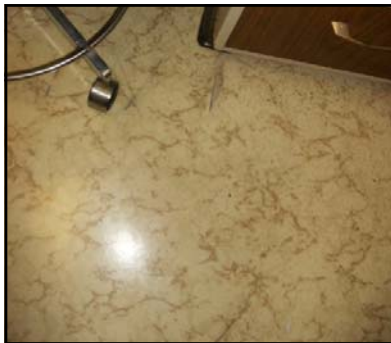
Sheet vinyl flooring

The paper backing on the underside of sheet vinyl flooring may contain friable asbestos. The paper backing has been generally found to contain 50% to 90% Chrysotile asbestos.

**Precautions:** Do not cut dry sheet vinyl flooring. Safe work procedures are required to repair or remove this type of flooring.

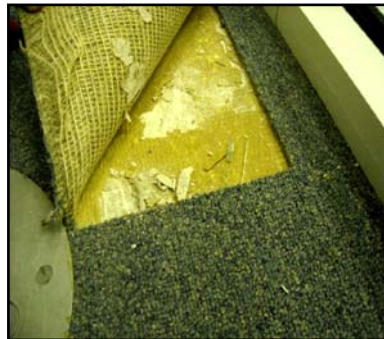
Floor leveling compound (FLC) is generally found under tile, sheet flooring and carpet. It may contain 1% to 75% Chrysotile asbestos and is generally grey, white or brown in both a fibrous or cementitious form. In some areas, there may be VAT and FLC under the carpet or multiple layers of VAT and FLC in one room.

White FLC under carpet

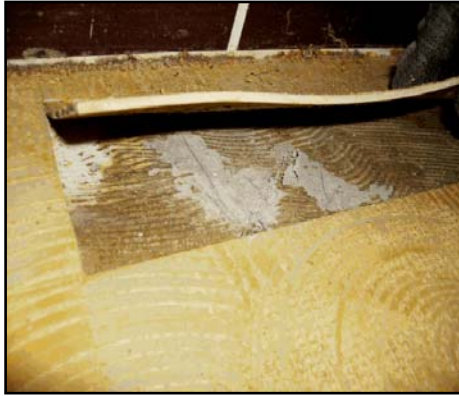
Grey FLC under floor tiles

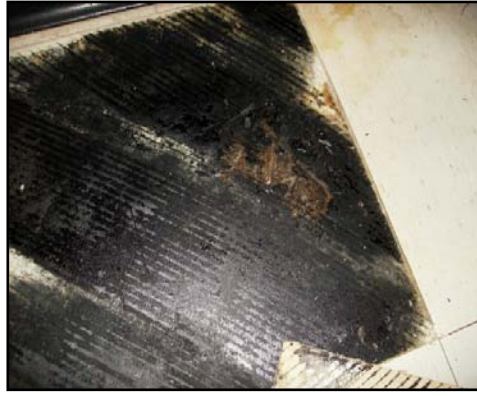
Black mastic under vinyl floor tiles

Mastic may also be present under VAT. It contains 1% to 10% Chrysotile asbestos. It is non-friable.

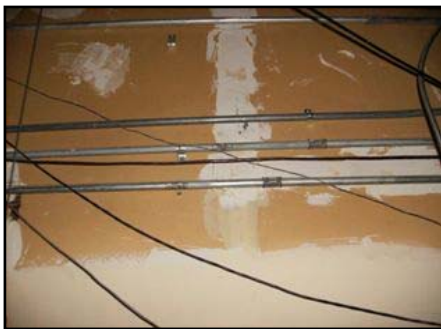
Drywall joint compound is often present along drywall seams, over screws, over steel corner beads and sometimes as a thin layer on the drywall. The asbestos content in joint compounds has generally been found to be 1% to 10% Chrysotile asbestos. Asbestos containing dust may be generated during wall repair or demolition.

Drywall joint compound

**Precautions:** Use hand tools and wet methods to minimize dust. If a drill is used, it must have a dust collection device fitted with a HEPA filter. Trained University staff may undertake only minor repair and/or maintenance work using safe work procedures specific to this activity.

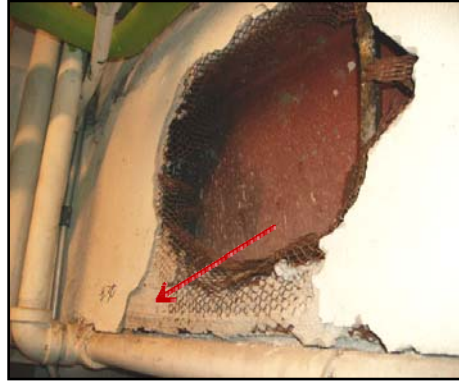
Asbestos may be present in all layers of plaster but is typically found in the coarse "base" or "scratch coat" layer of plaster (beige or grey in color) typically on metal or wood lathe. The asbestos content has generally been found to be 1% to 5% Chrysotile and/or Actinolite asbestos. Asbestos containing dust may be generated during wall repair or demolition.

Beige "scratch coat" plaster

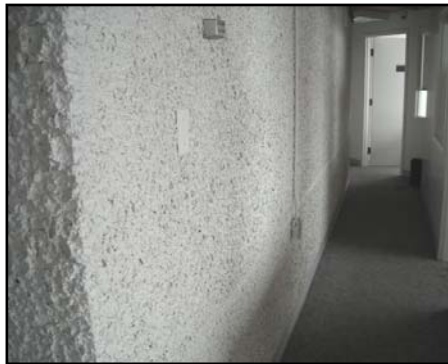
Decorative plaster (spray-applied)

Decorative plaster or "cement plaster" is mixed with cement and is either spray-applied or troweled. The asbestos content has generally been found to be 1% to 5% Chrysotile asbestos. Asbestos containing dust may be generated during wall repair or demolition.

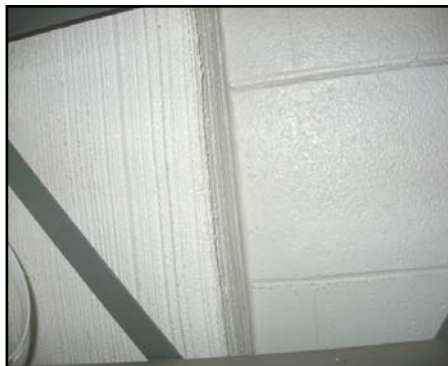
Decorative plaster (troweled)

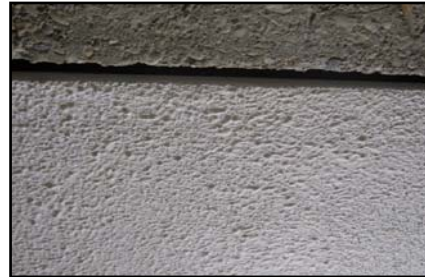
Stippled and textured ceiling finishes have been found to contain 1% to 50% Chrysotile asbestos. Stipple coat is typically applied as a thin, non-friable, layer on plaster or concrete whereas texture coat is applied as a thicker, more friable, layer.

Ceiling stipple coat

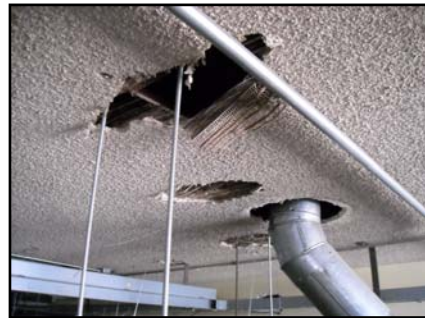
Ceiling texture coat

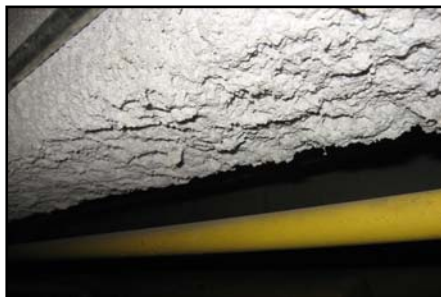
Spray-applied thermal/acoustic insulation is generally found in mechanical rooms and sometimes above suspended ceilings, on beams, metal decks, joists and columns. This type of insulation may contain 1% to 90% Chrysotile or Amosite asbestos and is very friable. Most asbestos containing spray-applied fireproofing insulation on campus has been removed or replaced with non-asbestos materials. If in doubt, request to have a sample taken for clarification.

Spray-applied thermal insulation (fireproofing)

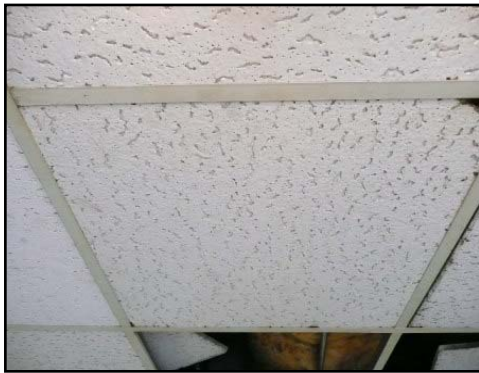
T-Bar ceiling tiles may contain 1% to 25% Chrysotile or Amosite asbestos. Asbestos ceiling tiles range from a wide variety of sizes including 1'x1', 2'x2', 2'x4', and 1.5'x6'. There may be asbestos and non-asbestos tiles in the same area. The only way to know for sure is by having the tiles tested. Generally, ceiling tiles with deep fissures and a red backing are more likely to contain asbestos. The majority of asbestos containing ceiling tiles have been removed from campus and replaced with non-asbestos materials.

T-Bar ceiling tile

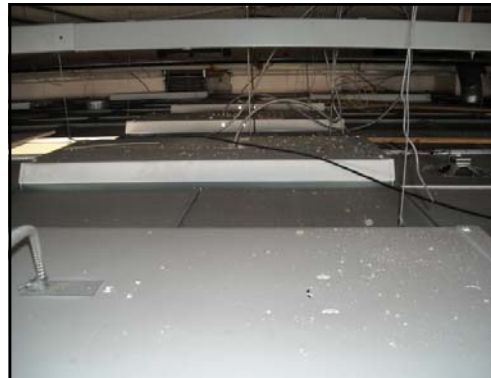
ACM debris may be found on top of ceiling tiles in areas that have spray-applied fireproofing, ceiling stipple/texture finishes or asbestos pipe insulation.

Texture coat debris on ceiling tiles & light fixtures

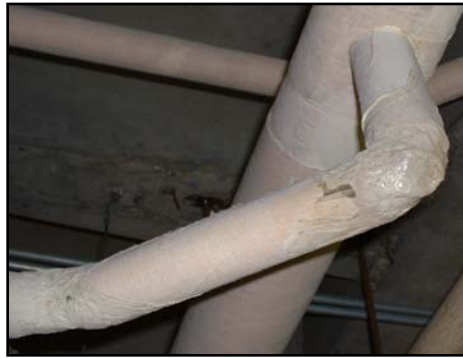
Pipe fitting insulation or “mud” includes a mixture of asbestos and cement on pipe elbows, joints, valves, reducers, hangers, etc. The mud is usually found wrapped with painted or non-painted canvas, but occasionally as bare mud. Mud may also be found applied on joints as a thin layer over fibreglass insulation and wrapped with canvas. This type of material usually contains 5% to 90% Chrysotile asbestos. It may occasionally be mixed with Amosite or Crocidolite.

Pipe elbow mud wrapped with non-painted

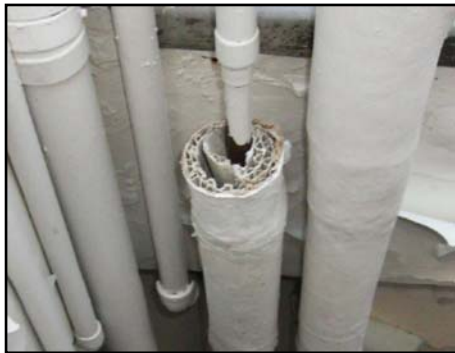
Corrugated “Aircell” insulation

Aircell looks like corrugated cardboard insulation and is found on straight lengths of pipes. It usually contains 25% to 90% Chrysotile asbestos. This type of insulation is friable.

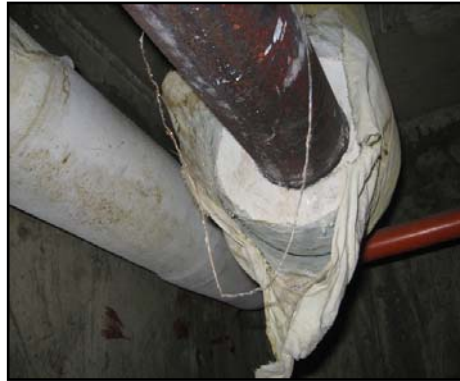
Block Insulation may be found on pipe runs and elbows. It is preformed as two half circle pieces that fit around a pipe. The two pieces are held together with either canvas and/or wire. It is generally found on high temperature steam lines and contains 50% to 90% Amosite and/or Chrysotile asbestos.

White solid block insulation

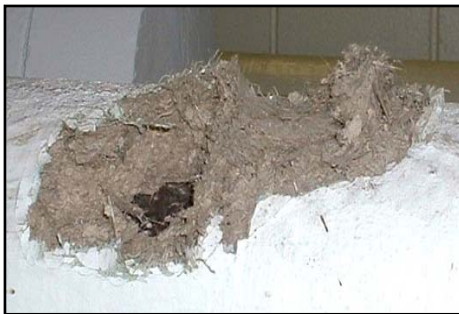
Brown solid fibrous insulation

Fibrous pipe insulation is another form of asbestos insulation that was used on pipe runs and elbows on high temperature steam lines. It contains 90% Amosite asbestos. It is very friable.

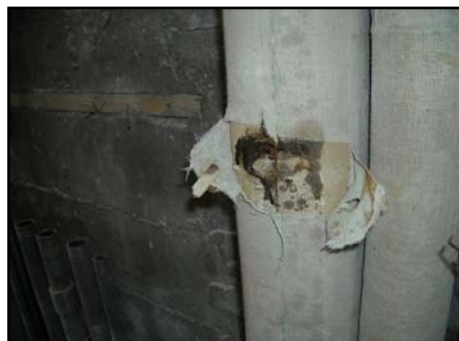
Asbestos containing construction paper is sometimes found on pipe runs covering layers of felt and fibreglass and wrapped with canvas. It typically contains 1% to 5% Chrysotile asbestos.

White construction paper insulation

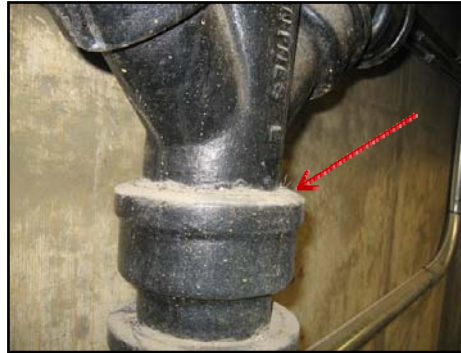
Oakum-type packing at cast iron pipe joints may contain ACM. It has been found to contain 1% to 75% Amosite or Chrysotile asbestos.

Joint packing on a cast iron pipe

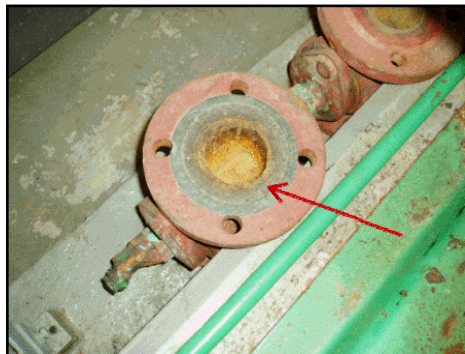
Pipe gasket

Gaskets at flanged pipe joints have been found to contain 50% to 75% Chrysotile asbestos. This material becomes very friable if disturbed or damaged.

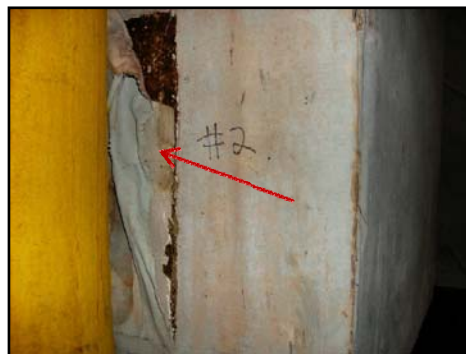
Parging cement is typically found on ducting as a thin layer between canvas and layers of felt, foil and/or fibreglass. It contains 5% to 90% Chrysotile asbestos.

Parging cement on duct

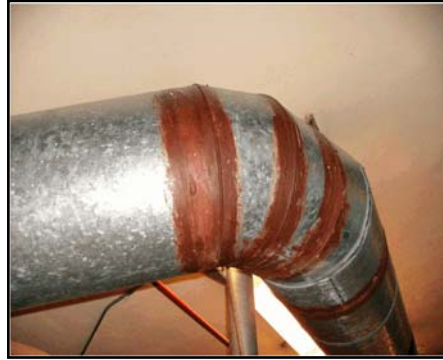
Mastic may be found along duct joints on bare ducts or on ducts covered with insulation. Asbestos has been found in various colors of mastics including red, black and yellow. It is a non-friable material. It has been found to contain 1% to 10% Chrysotile asbestos. Not all mastics contain asbestos. As a result, testing should be conducted prior to impacting the material.

Red duct mastic

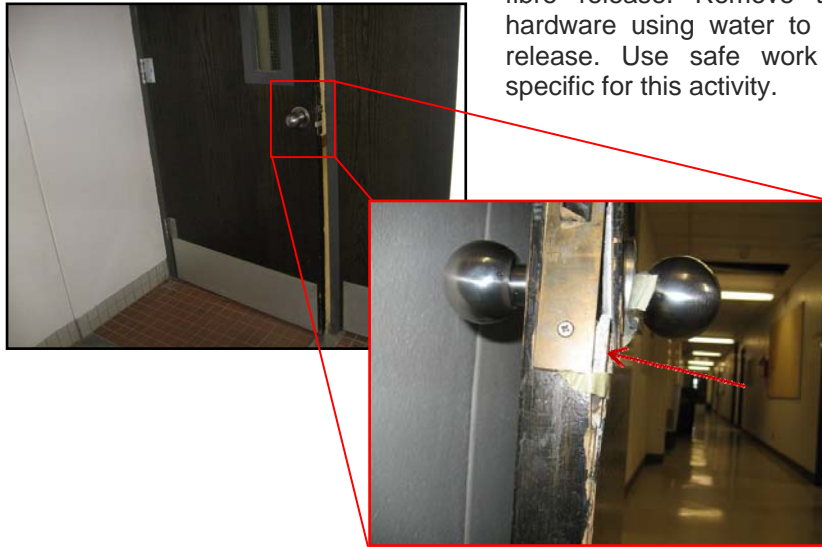
The interior filler of certain fire doors contain asbestos. It may be in a block or sheet form. It has been found to contain 50% to 90% Chrysotile and/or Amosite asbestos. The filler may be exposed when removing hardware or when the door is damaged. This material is very friable.

Fire door interior (white sheets of asbestos)

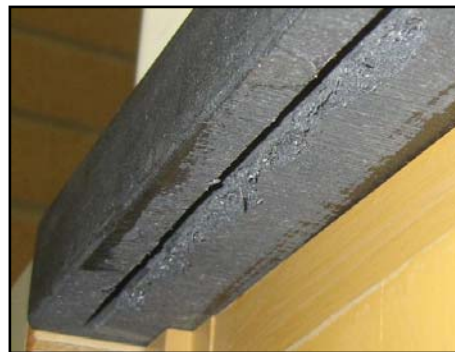
Countertops are located throughout campus buildings and are typically dark grey or green in color. This material is non-friable. It contains 5% to 50% Chrysotile asbestos.

Underside of countertop

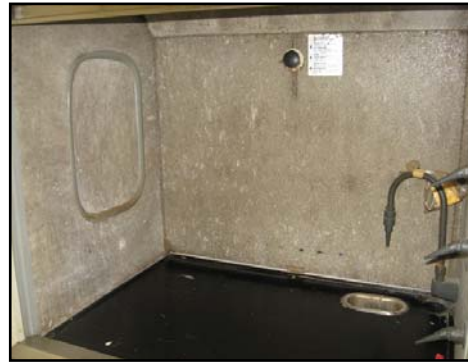
Cement board or “Transite” is a mixture of cement and asbestos. Due to its high resistance to heat and corrosion, cement board has been used in a wide range of applications. Examples include fume hood linings, flammable and chemical storage cabinets, roof and siding panels, perimeter heat register panels and wall and ceiling panels. It has been found to contain 5% to 90% Chrysotile asbestos. The material may also be painted.

Transite fume hood lining

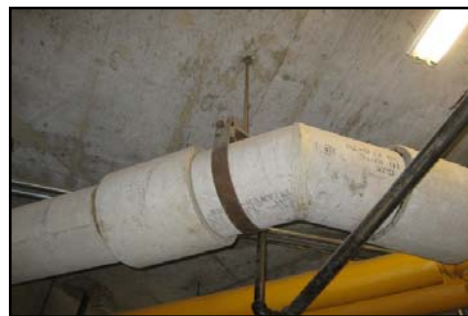
Transite pipe

Transite may also be found in the form of piping or ducting. Transite ducts are used to exhaust fume hoods and are generally found to contain 5% to 50% Crocidolite and/or Chrysotile asbestos. Transite pipes generally contain 25% to 50% Chrysotile asbestos.
